Flood damage and progress of repairs
Part IX
01 December 2023

DONKERKLOOF

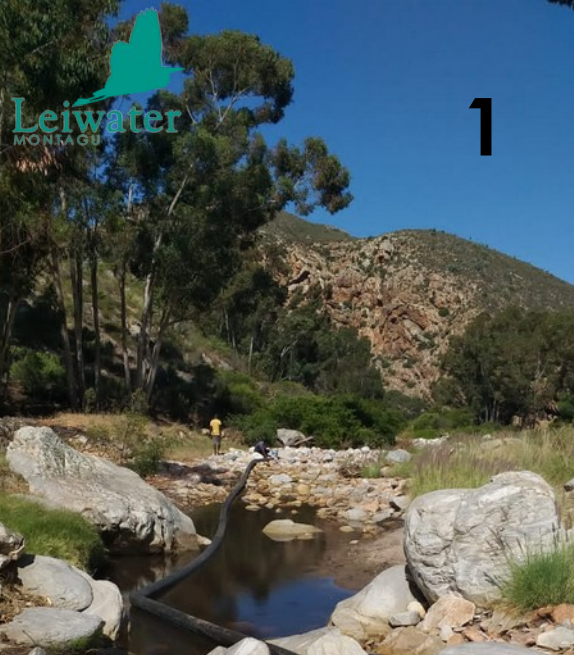
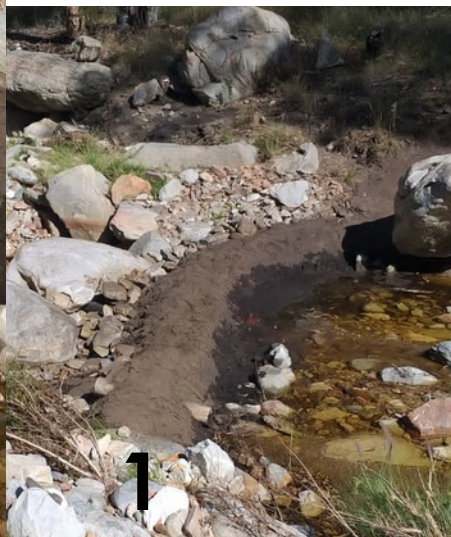
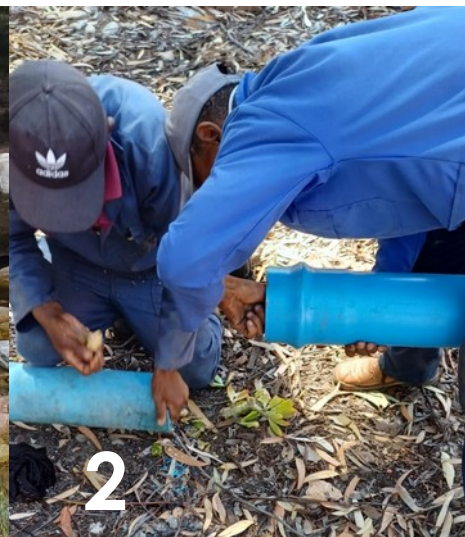
- 1) Kallie designed a new plan to get Donkerkloof water from further downstream, thus reducing our pipeline and costs. *Photos: Kallie Laubscher*
- 2) Kallie, Richard and team laid the new pipes. Here the guys are lubricating the pipes to connect them. *Photos: Richard Knipe*
- 3) Mitchell, Charlie, Jerome and Jannie laying the new pipe. *Photo: Richard Knipe*

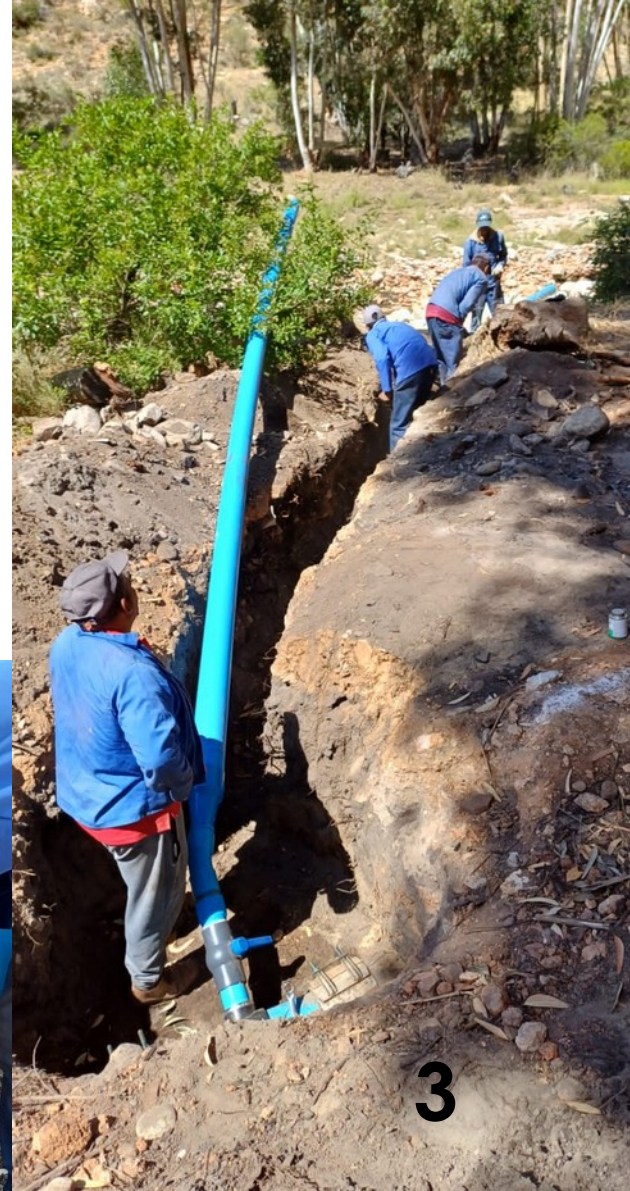
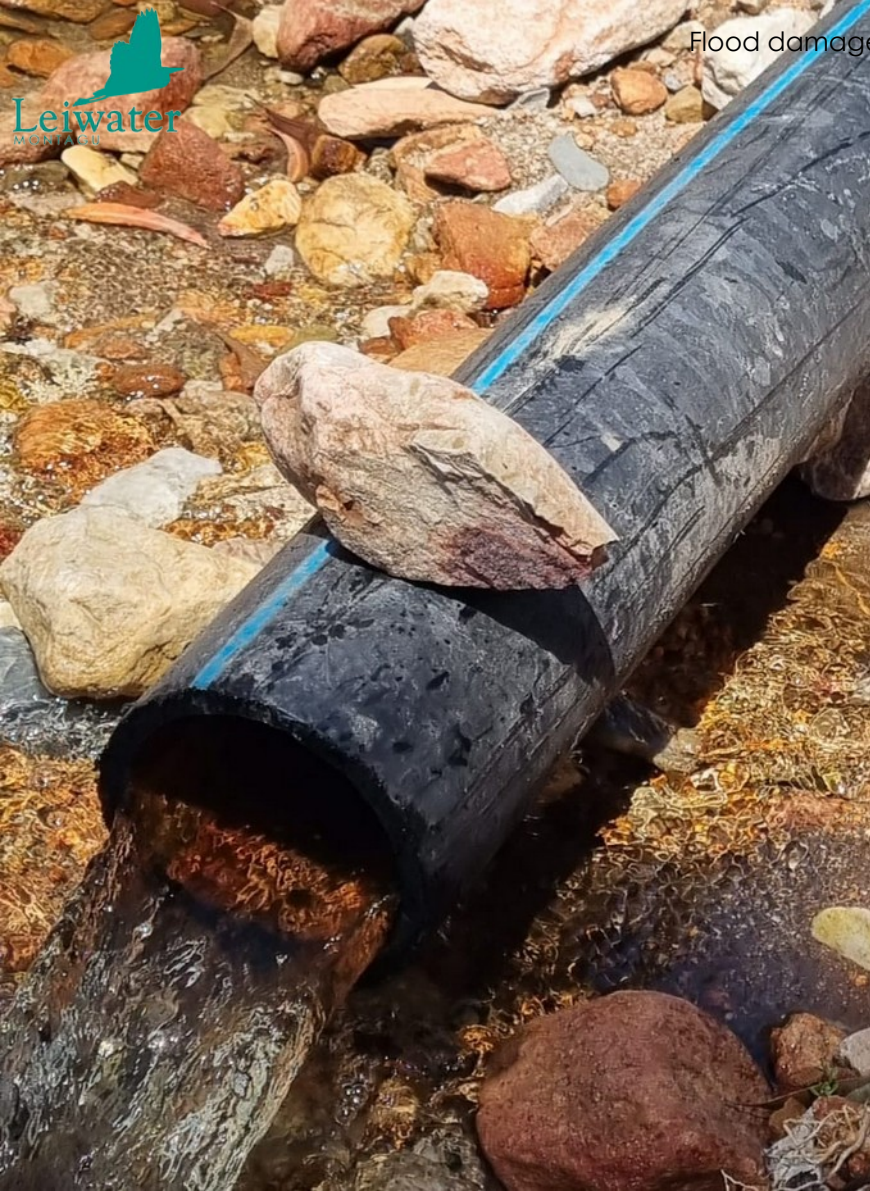
Now the water runs even more strongly than it did before, which means we improve the water quality. *Photos: Hugh Davies / Richard Knipe*

The salinity levels as tested by CBR water are currently (in mS):

Keisie:	151 (brak)
Donkerkloof:	17 (sweet)
Mixed:	123 (brak)

CBR considers 30-40 to be acceptable as sweet.

If we can increase the volume from Dkloof then we can further reduce the salinity.

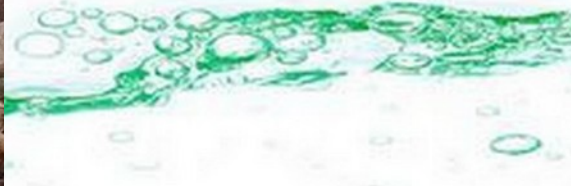
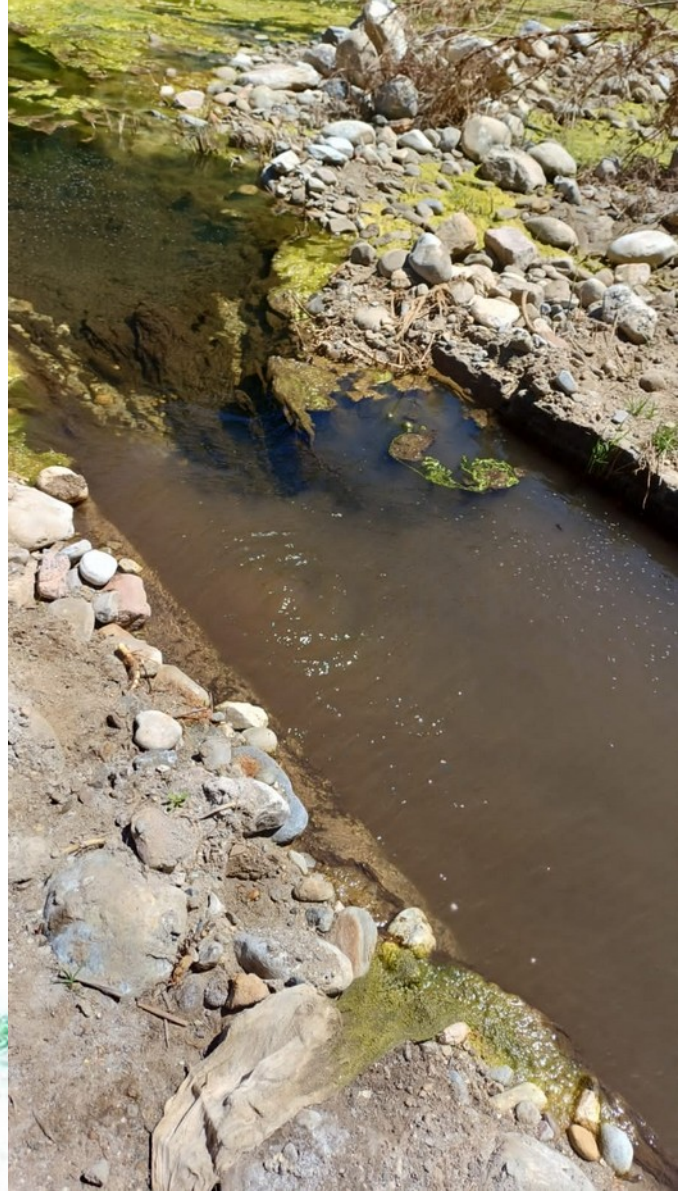
INKEERGAT

- 1) NS Staal in Robertson manufactured us three new deksels (covers) for the inkeergat. Richard painted them, and his team installed them. They are now anchored to the concrete, so we hope they will not wash away or be stolen. They each weigh about 70 kg, so it won't be easy to budge them! *Photo: Richard Knipe*
- 2) Labson & his team cleared a river channel further so that flow into the inkeergat is optimised. *Photo: Kallie Laubscher*
- 3) Temporary weir built to increase flow into inkeergat. *Photo: Kallie Laubscher*
- 4) Inkeergat with new covers installed! *Photo: Richard Knipe*
